CHICKAMAUGA HYDRO PLANT UNIT REALIGNMENT

AS A RESULT OF CONCRETE GROWTH

J. C. Jones and M. A. Thompson
Tennessee Valley Authority
Hydro Equipment Group
Chattanooga, Tennessee

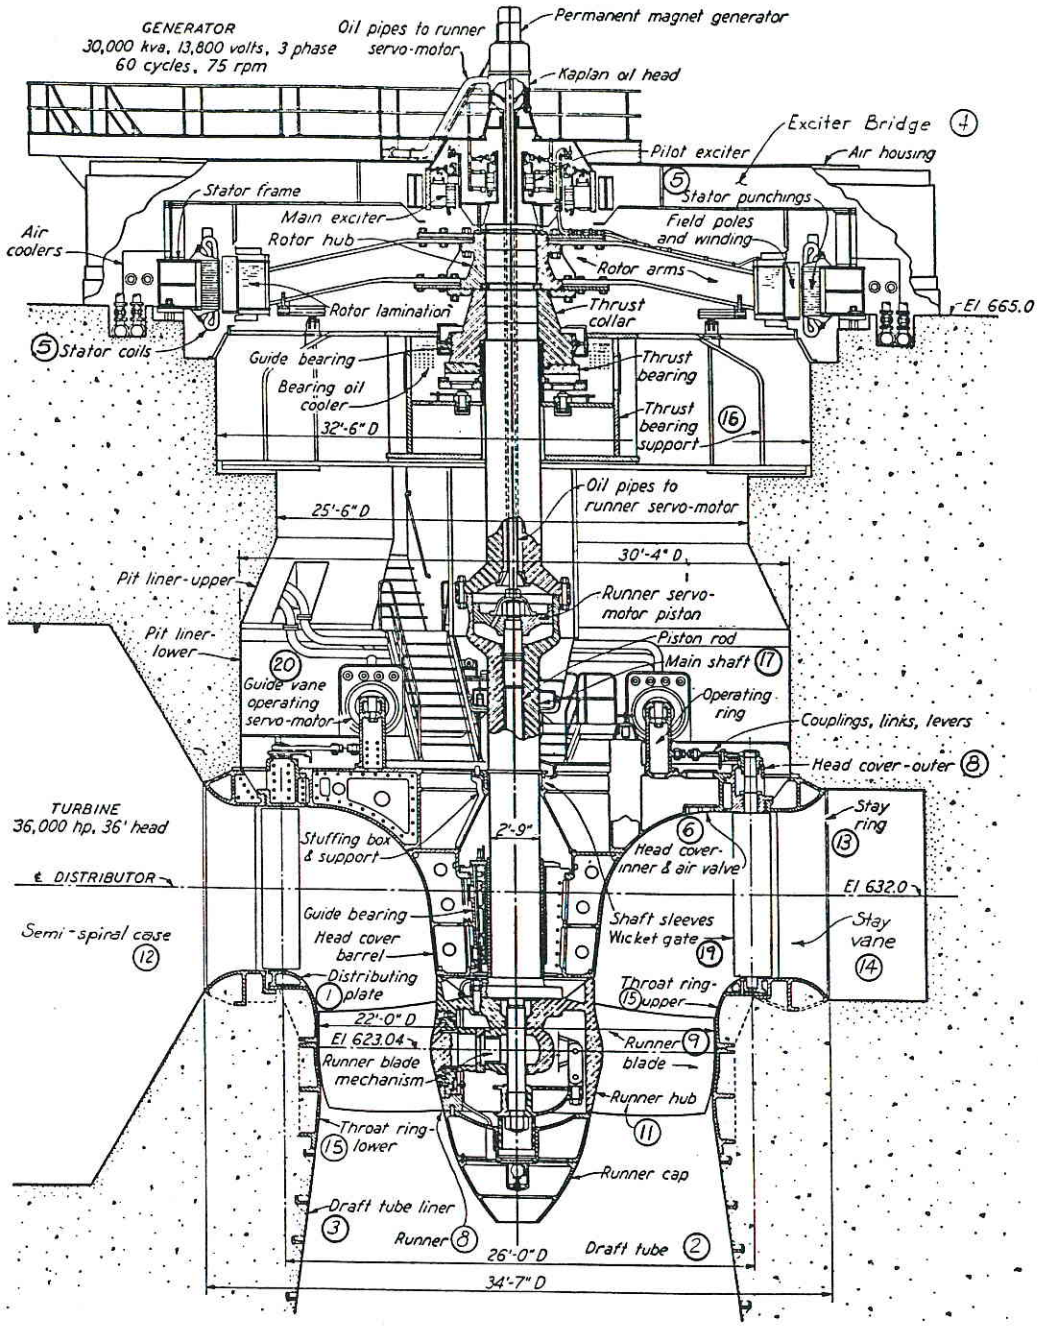
FIGURE 1 - SECTION THROUGH TURBINE-GENERATOR UNIT

Below is a list of the terms used in this paper.[1] An identification number is given by each item which also appears on Figure 1 to assist in identifying the component.

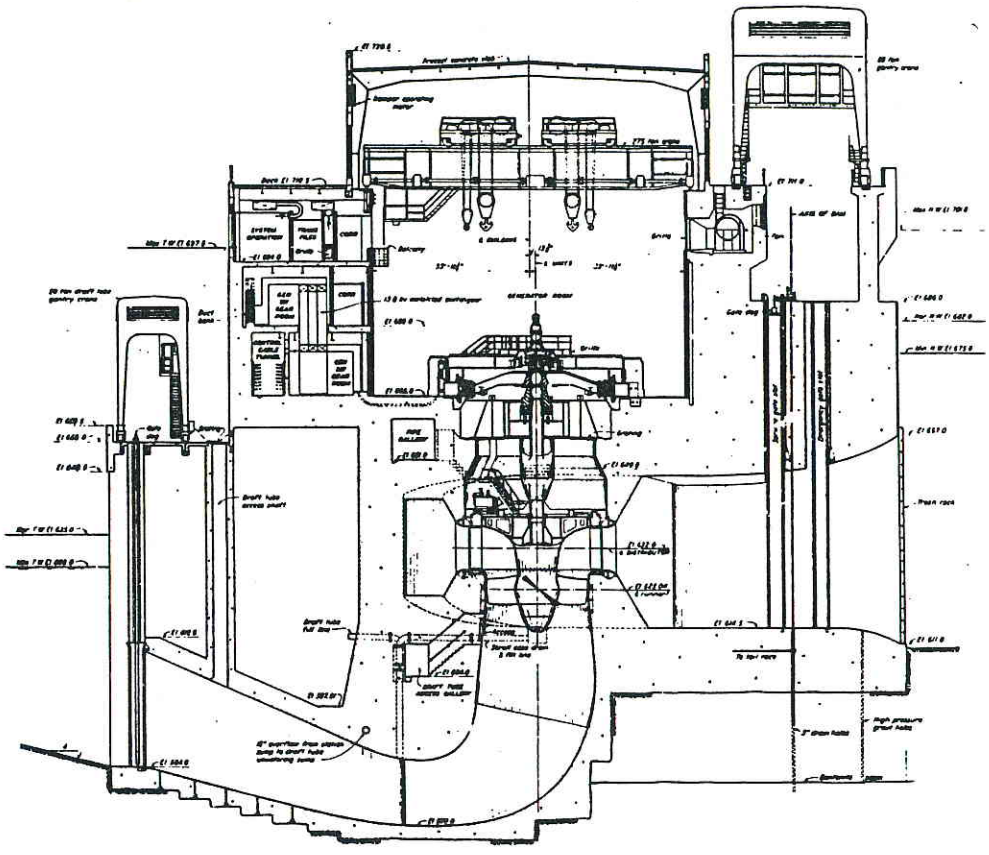
FIGURE 2- SECTION THROUGH POWERHOUSE (UNIT 1)

Units 1, 2, and 3 were initially installed and began operation in 1940. Unit 4 was placed in operation in 1952. All four vertical units utilize Kaplan adjustable-blade propeller turbines with a rated capacity of 36,000 horsepower (each) at 36 feet net head as shown in Figures 1 and 2. The generators are rated at 30,000 kilowatts resulting in a total plant capacity of 120,000 kilowatts.

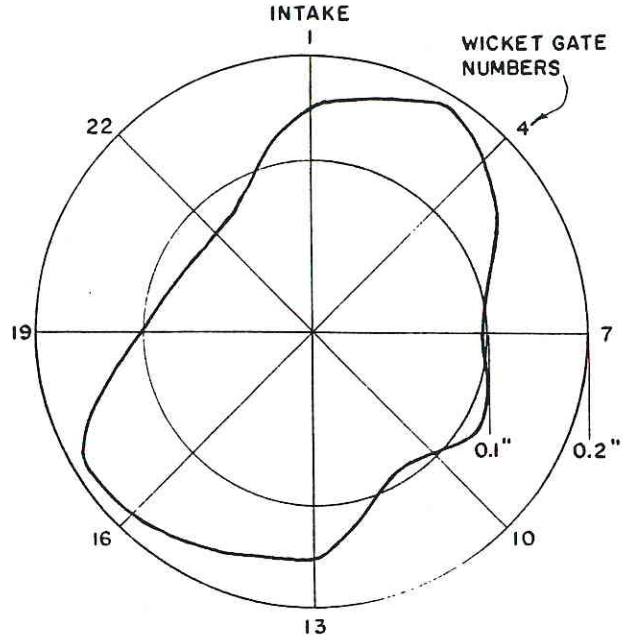
FIGURE 4 - PLOT OF THROAT RING

The 263.625-inch diameter Kaplan turbine runner at Chickamauga, runs with an Original Equipment Manufacturer (O.E.M.) design radial clearance of 0.1875 inch. As the concrete around the throat ring expands, it closes in on the runner and reduces this clearance. Thoughout the history of these units, it has been necessary, periodically, to air-arc and grind the throat rings to maintain adequate blade-to-throat ring clearance. Movement of the embedded parts not only closes the blade-to-throat ring clearance but it also causes havoc with the wicket gate assembly. On several occasions it has been found that the wicket gates of each unit could not be completely closed because of misalignment between the head cover and distributor ring. In 1980, unit 4 was disassembled and realigned because the wicket gates could not be completely closed.

Figure 4 is a plot of the distance from the plumb wire to the throat ring wall. Figure 6 is a plot of the distance from the plumb wire to the center of the wicket gate bushing holes in the distributor ring. It is interesting to note that both of these plots are eggshaped and the axis of the major diameters coincide with the location of the nose vane as shown in Figure 3. Since the nose vane is located where the semi-spiral case has its minimum cross-sectional area, this would be where the embedded parts have their greatest structural support. The support of the embedded parts gradually decreases as the cross-sectional area of the semi-spiral case increases and approaches the intake as shown in Figures 2 and 3. We believe this explains the shape of the throat ring shown in Figure 4 and the direction of movement for the embedded parts.

In the past, as a temporary fix, areas on the throat ring were air-arced and ground smooth to maintain some blade clearance. This was corrected by building up the shallow areas with 308 stainless steel. Deep areas were built up with mild steel and then capped with 308 stainless steel. The throat ring was then ground to the proper diameter and contour.

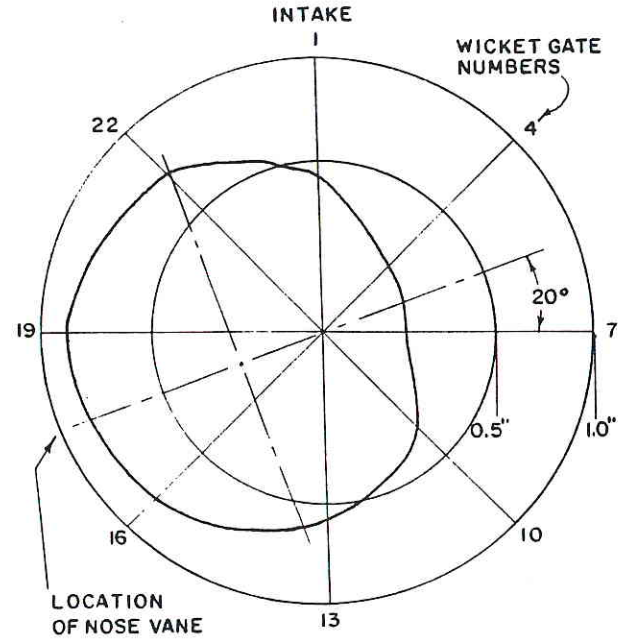
FIGURE 5 - PLOT OF OUTER HEAD COVER

Figure 5 is a plot of the distance from the plumb wire to the inner head cover-to-outer head cover fit on the outer head cover. The plot shows that the head cover is misaligned with the center of the throat ring by approximately 0.500 inch 20 degrees counterclockwise with the axis of the powerhouse. We believe that most, if not all, of this misalignment resulted from the movement of the lower part of the stay ring (including the throat ring and distributor ring) due to the shape of the throat ring shown in Figure 4. This means that the center of the throat ring has moved rather than the center of the outer head cover.

The wicket gates at Chickamauga are designed to operate with 0.040 inch end clearance. Calculations reveal that if the head cover is moved 0.250 inch out of line with the distributor ring, the end clearance will be exhausted and the gates will rub the head cover and distributor ring. Since a misalignment of 0.500 inch was found in unit 4, this explains why the wicket gates could not be completely close.

In order to realign the unit, the outer head cover, thrust bearing support bridge, and generator stator had to be moved and centered with the throat ring.

The outer head cover was removed from the stands and lowered back into place. Four aluminum plates were fabricated and installed in the wicket gate thrust bushing holes of gate numbers 3, 8, 14 and 20. A plumb wire was suspended through the center of each plate with a small plumb-bob attached and located in the corresponding bushing holes in the distributor ring. Measurements were taken and a move was plotted for the outer head cover. A small amount of metal had to be removed from the inside of the stay ring and the outer head cover flange bolt holes had to be elongated in order to move the outer head cover. The outer head cover was shifted to attain a compromise of all twenty-four wicket gate bushing holes and the center of the throat ring.
